REPORT: Geophysical Logging Results
Borings B-2L, B-3L and B-9L
Lower Alignment, Index – Galena Road, Mileposts 6.4 to 6.9
Snohomish County, Washington

Index Galena Flood Repair Project
Mileposts 6.4 to 6.9
Snohomish County, Washington

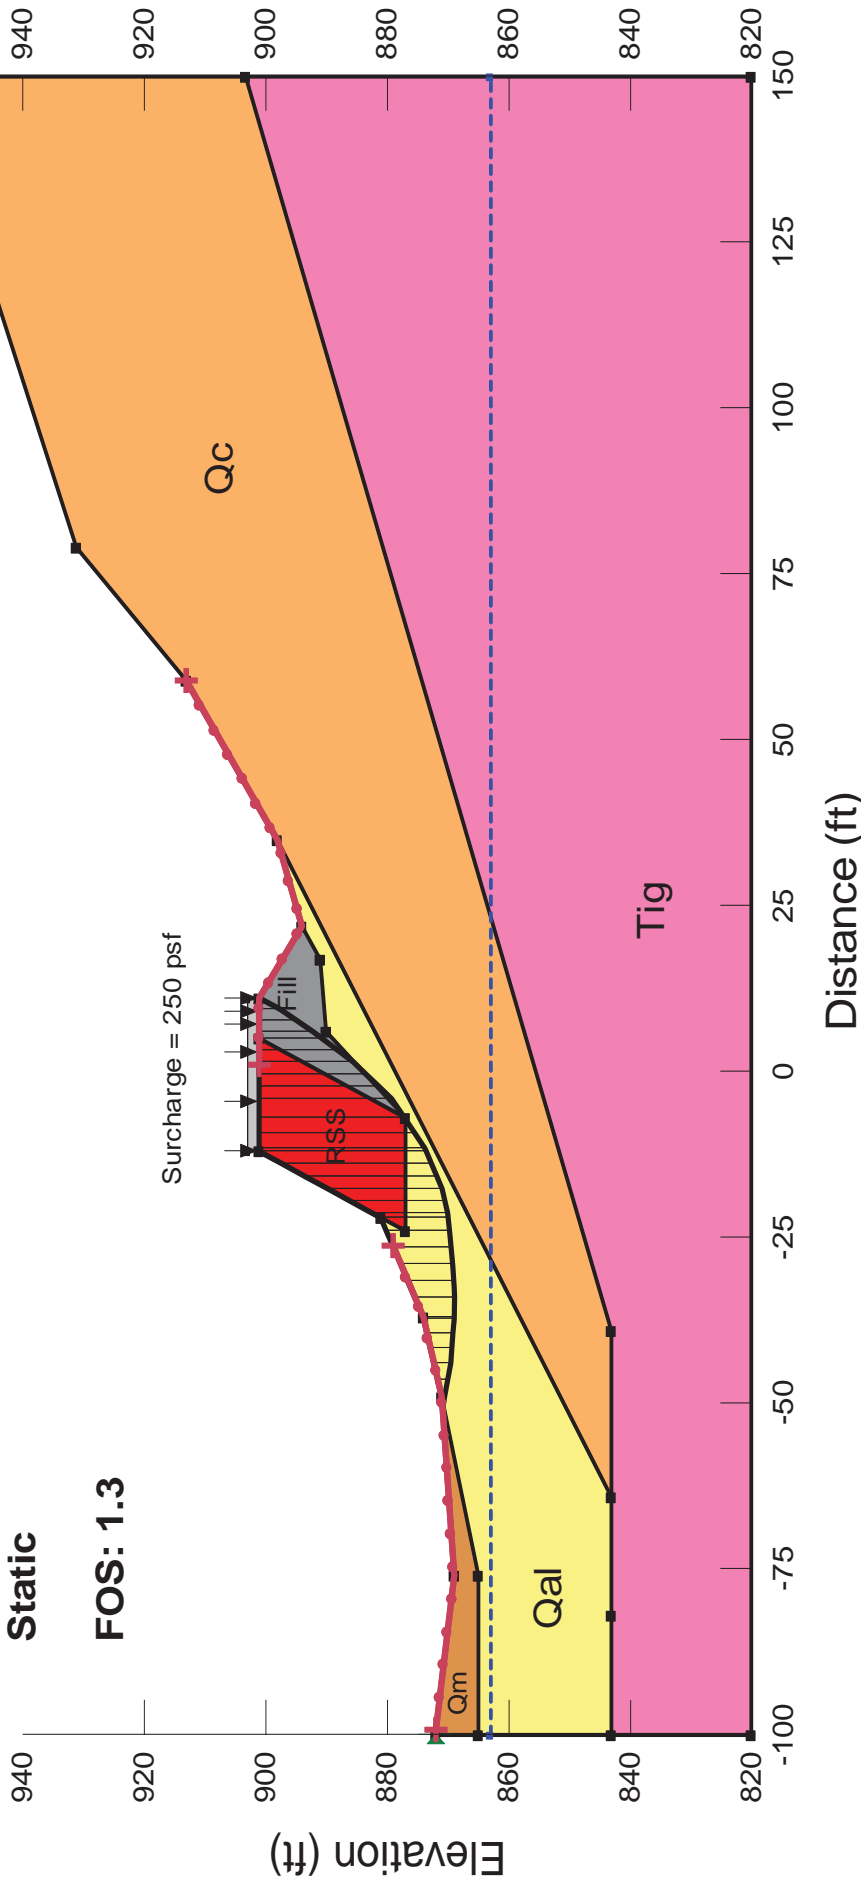
**Index-Galena Road
21-1-21116-031
STA 52+75
Static**

FOS: 1.3

Soil Parameters:

- Qc: Unit Weight - 135 pcf, Friction Angle - 42°
- Qal: Unit Weight - 125 pcf, Friction Angle - 32°
- Qm: Unit Weight - 110 pcf, Friction Angle - 26°
- Fill: Unit Weight - 130 pcf, Friction Angle - 34°

Index Galena Flood Repair Project Mileposts 6.4 to 6.9 Snohomish County, Washington	
STA 52+75 GLOBAL STABILITY 0.5H:1V RSS STATIC CONDITIONS	
December 2012	21-1-21116-031
SHANNON & WILSON, INC. Geotechnical and Environmental Consultants	FIG. F-13

F-1	STA 26+75 Global Stability, 0.5H:1V RSS, Flood Level Conditions
F-2	STA 40+50 Global Stability, MSE Wall, Static Conditions
F-3	STA 40+50 Global Stability, MSE Wall, Flood Level Conditions
F-4	STA 44+00 Global Stability, Soldier Pile Wall, Static Conditions
F-5	STA 44+00 Global Stability, Soldier Pile Wall, Earth Pressure Analysis
F-6	STA 44+00 Global Stability, Soldier Pile Wall, Flood Level Conditions
F-7	STA 46+25 Global Stability, Existing Qvrl Slope, Without Drains
F-8	STA 46+25 Global Stability, Existing Qvrl Slope, With Drains
F-9	STA 48+00 Global Stability, MSE Wall, Static Conditions
F-10	STA 48+00 Global Stability, MSE Wall, Flood Level Conditions
F-11	STA 52+25 Global Stability, 1.5H:1V Rockfill Slope, Static Conditions
F-12	STA 52+25 Global Stability, 1.5H:1V Rockfill Slope, Flood Level Conditions
F-13	STA 52+75 Global Stability, 0.5H:1V RSS, Static Conditions
F-14	STA 52+75 Global Stability, 0.5H:1V RSS, Flood Level Conditions

Station Analyzed	Feature Analyzed	Approximate Wall, RSS, or Embankment Height	Foundation Soil	Static Factor of Safety	Flood Level Factor of Safety
26+75	0.5H:1V RSS	27 feet	~2H:1V Qc Slope	1.6 (not shown)	1.6 (Fig. F-1)
40+50	MSE Wall	29 feet	Qc/Qal	2.1 (Fig. F-2)	1.9 (Fig. F-3)
44+00	Soldier Pile Wall	11.5	~30° Qvrl/Qc/Qal Slope	1.3 (Fig. F-4, Earth Pressure Analysis - Fig. F-5)	1.2 (Fig. F-6)
46+25	Existing Slope	--	~30° Qvrl/Qc/Qal Slope	Without Drains: 0.9 With Drains: 1.3 (not shown)	Without Drains: 0.9 (Fig. F-7) With Drains: 1.3 (Fig. F-8)
48+00	MSE Wall	13 feet	~1.2H:1V Qc Slope	1.5 (Fig. F-9)	1.4 (Fig. F-10)
52+25	1.5H:1V Rock Fill Slope	19 feet	~1.5H:1V Qal Slope	1.3 (Fig. F-11)	1.2 (Fig. F-12)
52+75	0.5H:1V RSS	24 feet	~2H:1V Qal Slope	1.3 (Fig. F-13)	1.1 (Fig. F-14)

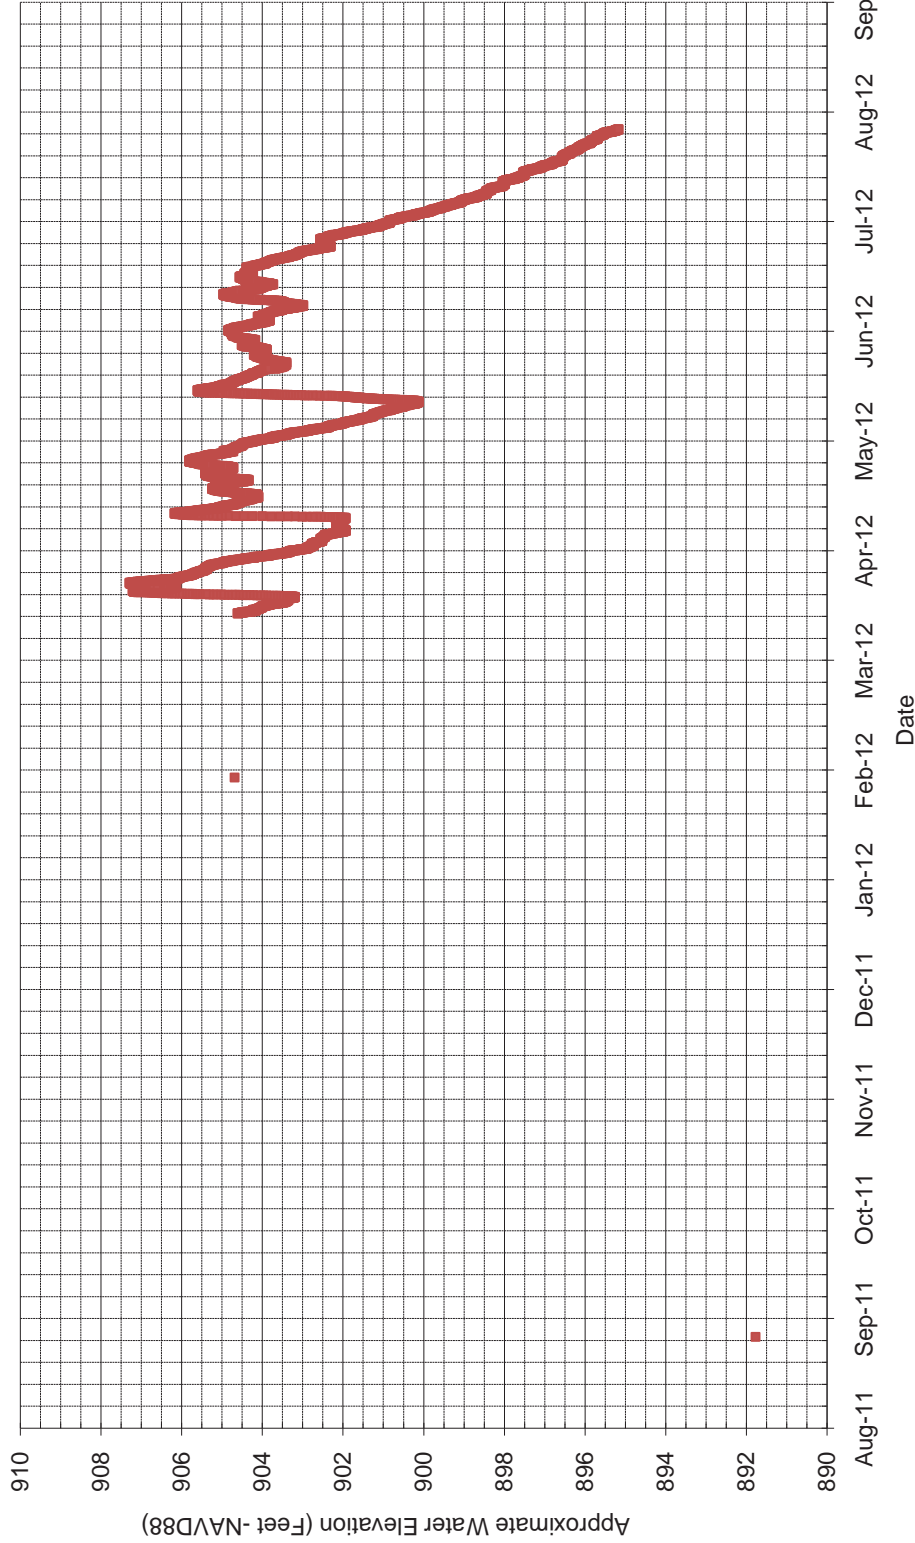
FIG. G-1

- G-1 Groundwater Elevation Boring B-3L
- G-2 Groundwater Elevation Boring B-5L

■ B-3L VWP 1118385

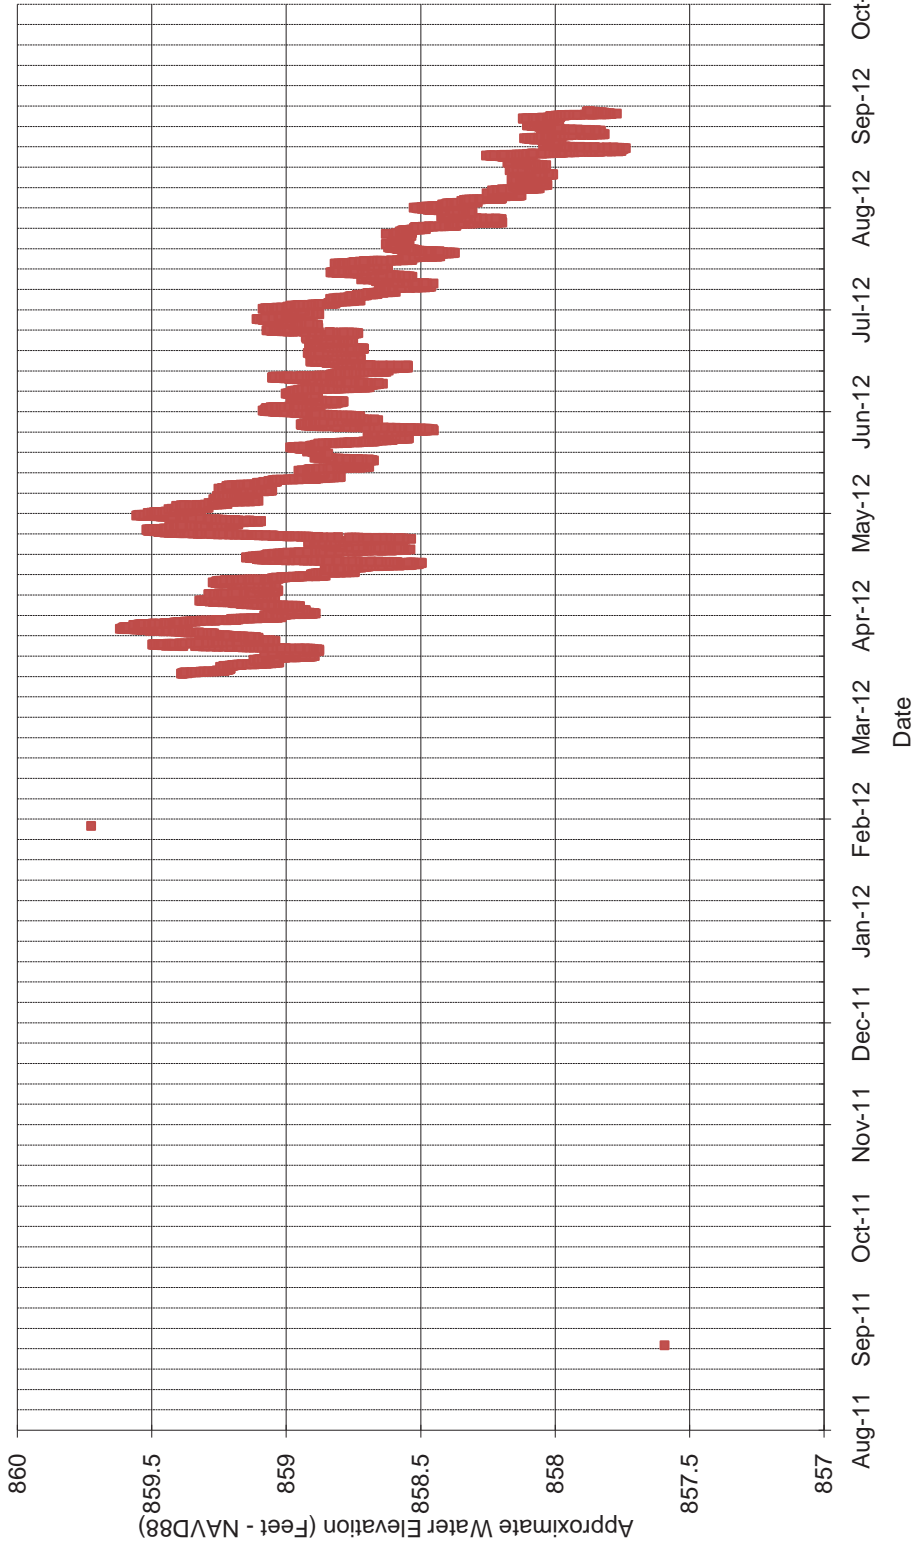
■ B-5L VWP 1119399
